WHALES ON WHEELS

SPRING 1989

VOLUME VIII NUMBER 2

COOLING THE CORVAIR AUTOMATIC TRANSMISSION

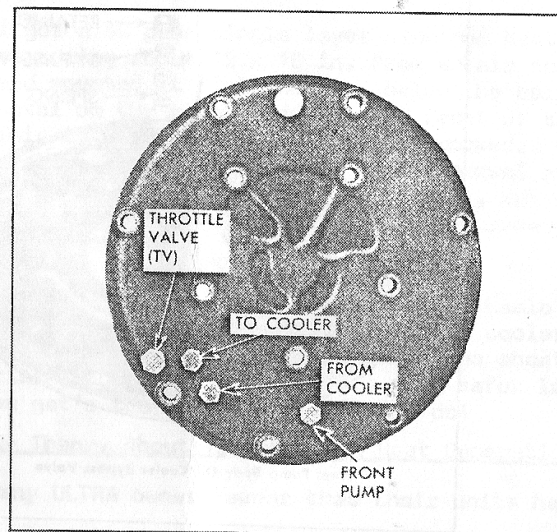
Fig 1.

-Front Pump Cover Plug Identification

As an added cost option G.M. provided a trans cooler in their Forward Control vehicles. This consisted of a special front pump plate with a bypass valve built into it (see Fig. 2) and a front plate that has four (4) holes drilled and tapped for 1/8" pipe fittings (see Fig. 1). The bypass valve permits normal operation of the trans if the cooler plugs up or if you don't want to use the cooler. I found such a special front pump plate and front cover and installed them on my van. I made the cooler out of an air conditioning heat exchanger and installed it

First, the front plate (Fig. 1) has to have two holes drilled and tapped for the "To cooler" and "From cooler" lines to the outside heat exchanger. Find the smooth round spots between the two existing plugs. Mark the centers and drill and tap for a 1/8" pipe fitting. Do not tap too deep or the fittings will screw in too far!!

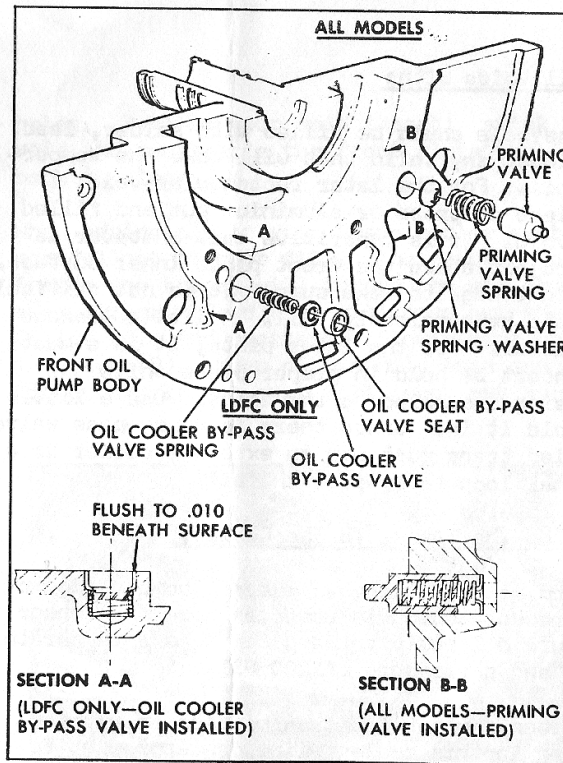
Fig 3.

-Front Pump Body and Components

Early transmissions (1960 to 1963) have a deep key-hole shaped void and no priming valve. Later transmission (1964 to 1969) have a flat rectangular (3/4 x 1/2") void about 1/8" deep and the priming valve (Fig. 3). Most ULTRA van's have the later transmission unless it has been replaced.

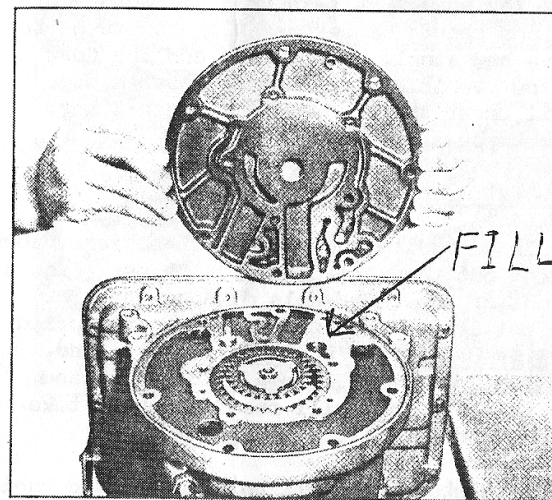
Fig 4.

-Installing Front Pump Cover

The second requirement is to fill the small void (Fig. 4) that will be right behind the cooler exit in the front plate. This void normally shunts the hot oil coming back from the converter directly down into the pan. Even as you drill and install an external cooler, if this void isn't filled, the oil will not go to the cooler, but continue un-cooled to the pan.

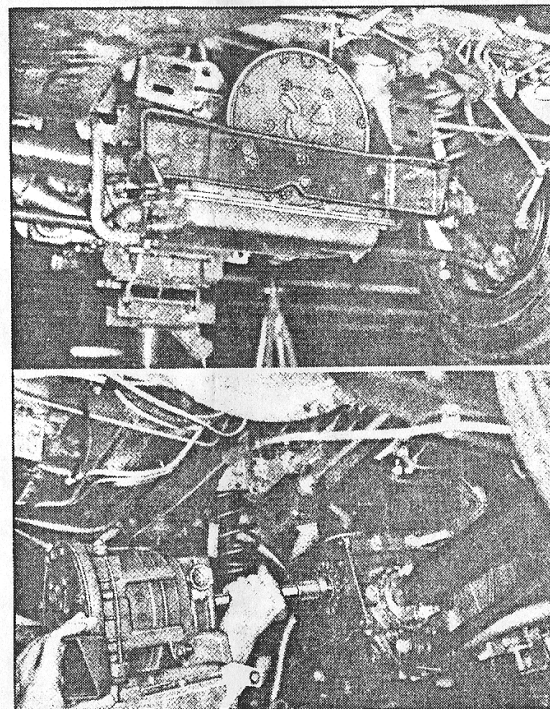
Fig 6.

-Removing Powerglide from Vehicle

It is possible to modify the two items mentioned above without taking out the transmission. As per (Fig. 6), drop the front of the trans-axle down so that the front plate bolts can be remove and the plate pried out. DO NOT TAKE THE PUMP PLATE OUT! If you do, most of the inside guts will come sliding out and then you're in a fix that will require you to take the trans. out and bench it for reassembly.
