WHALES ON WHEELS

POWERGLIDE TRANSMISSION ISSUE

SUMMER 1990

VOLUME IX NUMBER 3

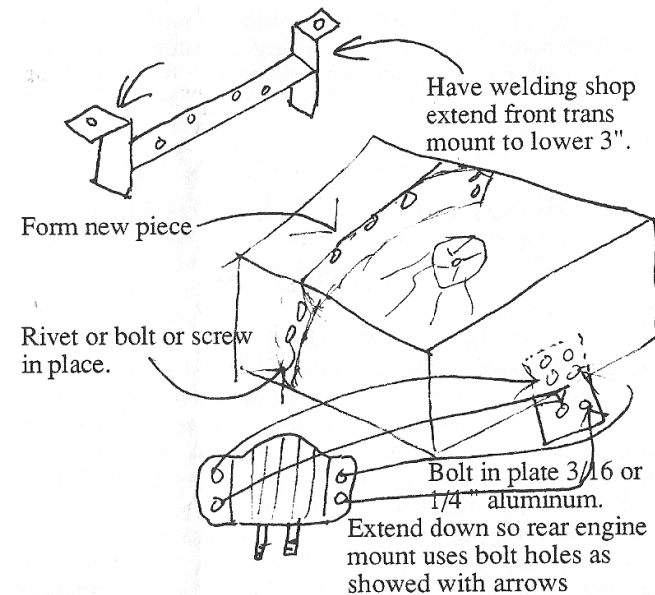
LOWERING THE ENGINE

This can have many benefits, the most important is less strain of the universals joints. Better geometry is accomplished for the drive axles. In less than 4 hours you can change out the drive assembly.

Using the sheet metal from a 1965 or later model Corvair with no modifying. Install a new Corvair rubber

seal to walls of original sides and rear of engine box. Also to the new front panel you have made.
